**CORROSION IN
VERTICAL TURBINE PUMPS**

BY
T. E. LARSON

VOL. 94, NO. 4

APRIL, 1947

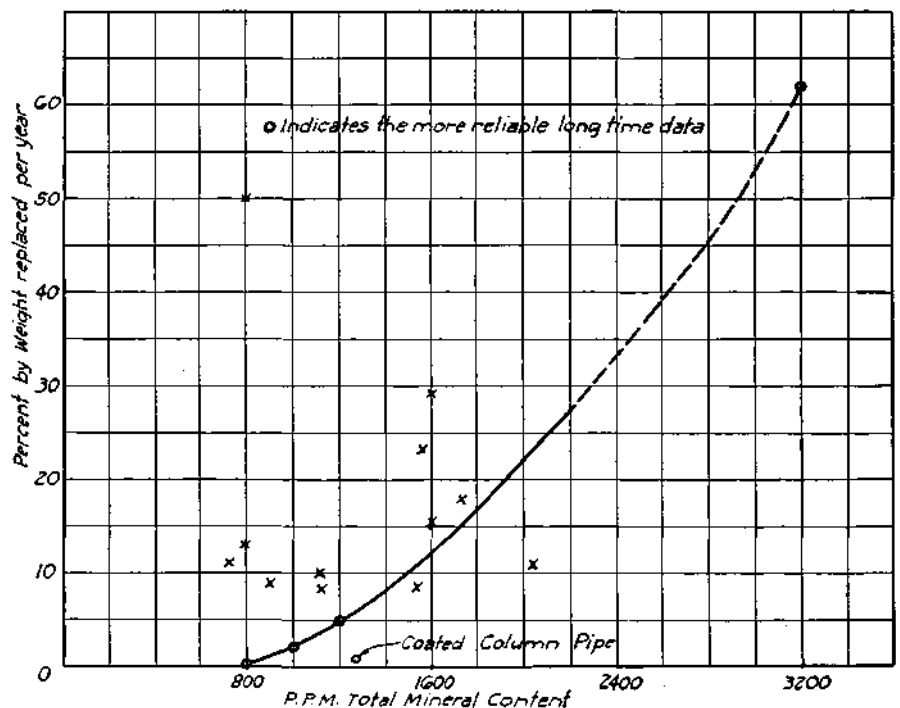
Fig. 1. Replacement of Pumps Plotted Against Mineral Content of Water

The curve in Fig. 1 indicates the effect of water quality on galvanic action and also on general corrosion as may result from contact of mineralized water with any piece of steel or cast iron. Since the original publication of this curve (JAWWA 36, 886, 1944) nearly all of the points greatly distant from the curve have been explained by stray currents or by a high gas content.

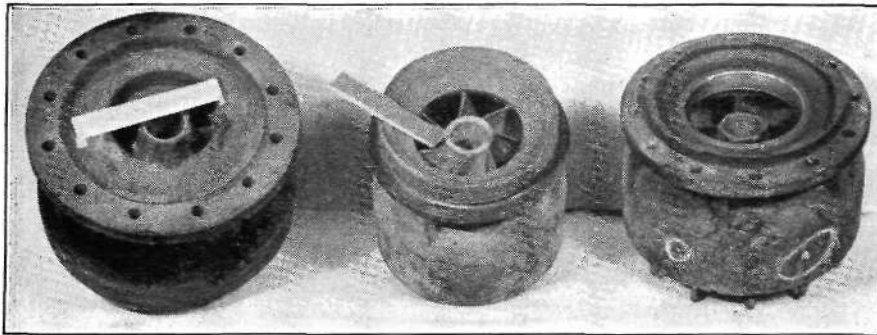
Examples of Corrosion in Vertical Turbine Pumps

Flanged 12 in. all cast iron bowl. Diameter at impeller ring 4% in. (originally 4% in.) after 9 months' operation. Capacity reduced from 700 gpm. to 300 gpm. Also note corrosion at high pressure side of guide vanes and of cast iron bearing support. Water contained 1000-1500 ppm. mineral content and a high CO_2 content.

Threaded 9 in. enameled cast iron bowl. Graphitization indicated on impeller

seat and on exposed cast iron bearing support. Extent of corrosion in 13 months indicated by shadow below straight-edge. Stray currents were also recorded at this well where water of 1100 ppm. mineral content was used.

Flanged 12 in. cast iron bowl with wear ring. After 14 years' service, two holes noted on bowl and much graphitization was evident on all cast iron exposed to water of 400 ppm. mineral content but considerable gas content.

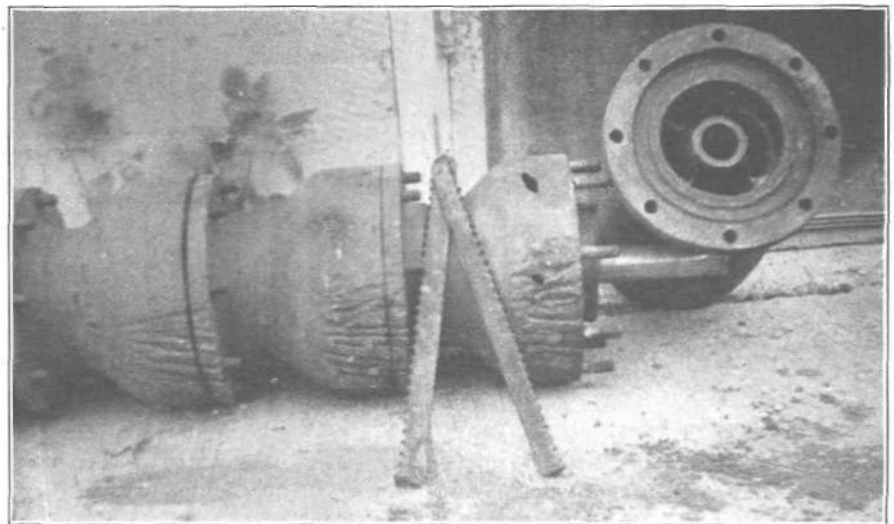
A Combination of Galvanic and CO₂ Attack

The effect of galvanic action is visible on the exterior of this 7-stage 10 in. C.I. well pump which had been in contact with a brass well screen for about 5 years. The two tooth-edged strips are remnants of the brass strainer.

Through the walls of the bottom bowl of the pump are two holes resulting from CO₂ corrosion. The water had a mineral content of about 500 ppm., alkalinity of 400 ppm., and a high methane and carbon dioxide content.

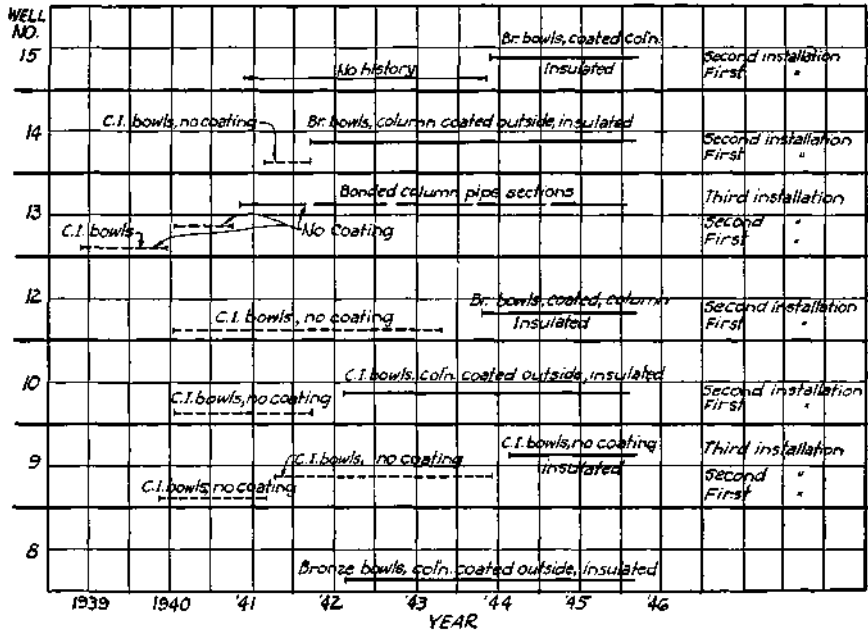
Fig. 2. Pump History
The length of life is indicated by the length of the line.

Fig. 2 shows the history of pump replacements in seven wells used by an industry whose property is overrun by stray currents from their operating machinery.
