REPORT OF INVESTIGATION NO.7

THE SILTING OF RIDGE LAKE

Fox Ridge State Park

Charleston, Illinois

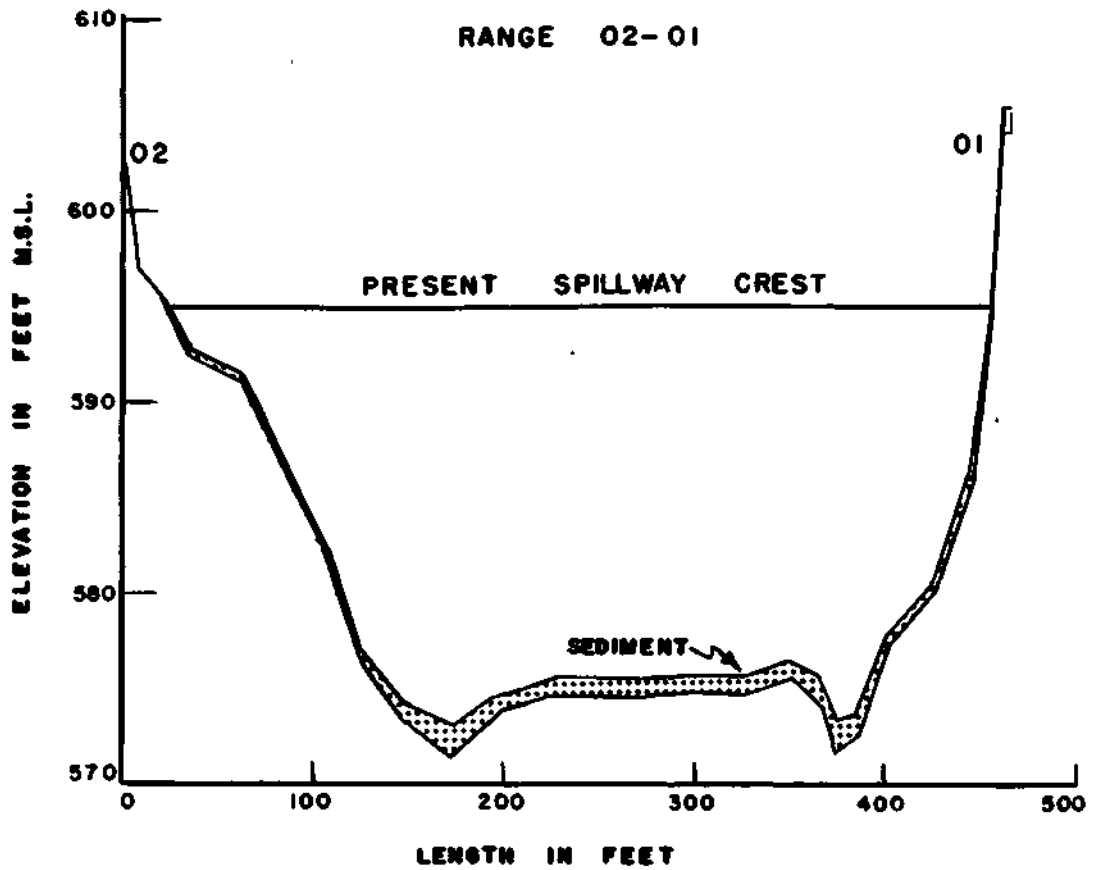
NOTE : VERTICAL SCALE EXAGGERATED 10 TIMES

Figure 5. Typical Silt Cross Sections-Ridge Lake.

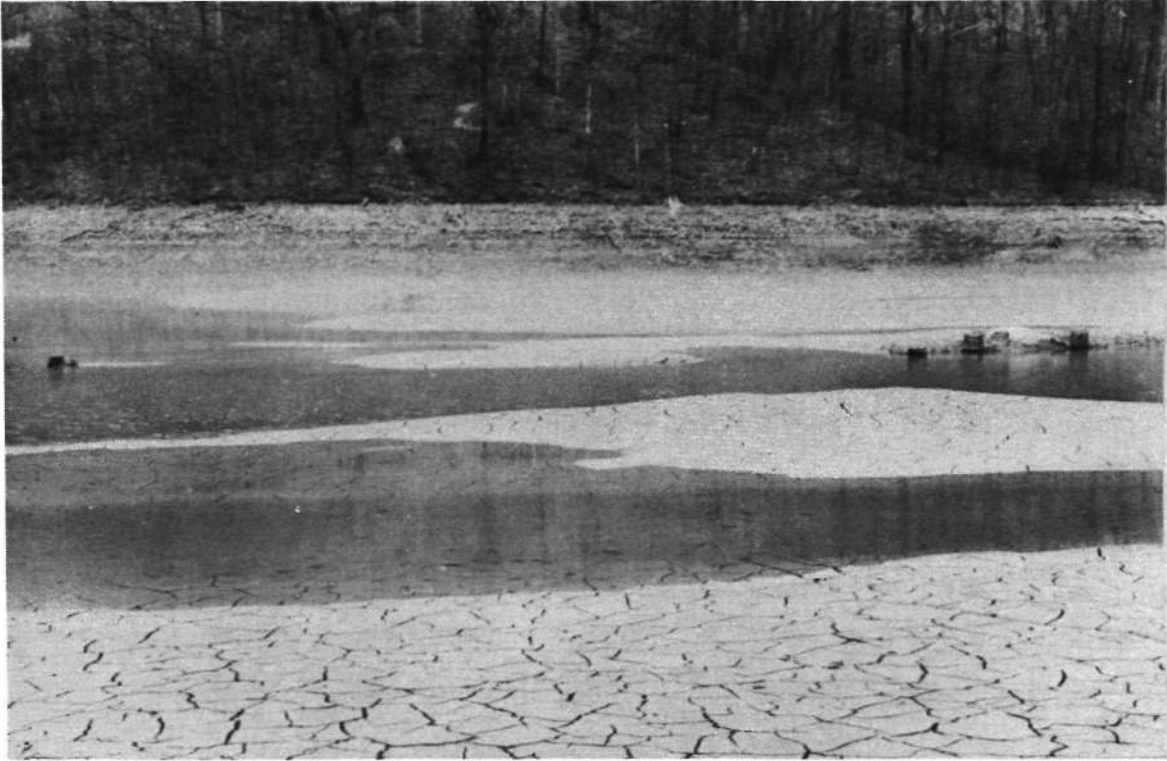
Figure 6. Sediment Deposit on Reservoir Bottom.

Upon occasion of the periodical drainings of the lake for fish counting, it was possible to inspect and photograph the sediment deposits in the bottom of the lake. Figure 6 shows a general view of the bottom of the lake in the lower portion or main body of the lake. The silt shown is approximately 1 to 2 feet in thickness. Silt has practically filled the original stream channel and has deposited in a uniform blanket on the pre-reservoir valley flatland.

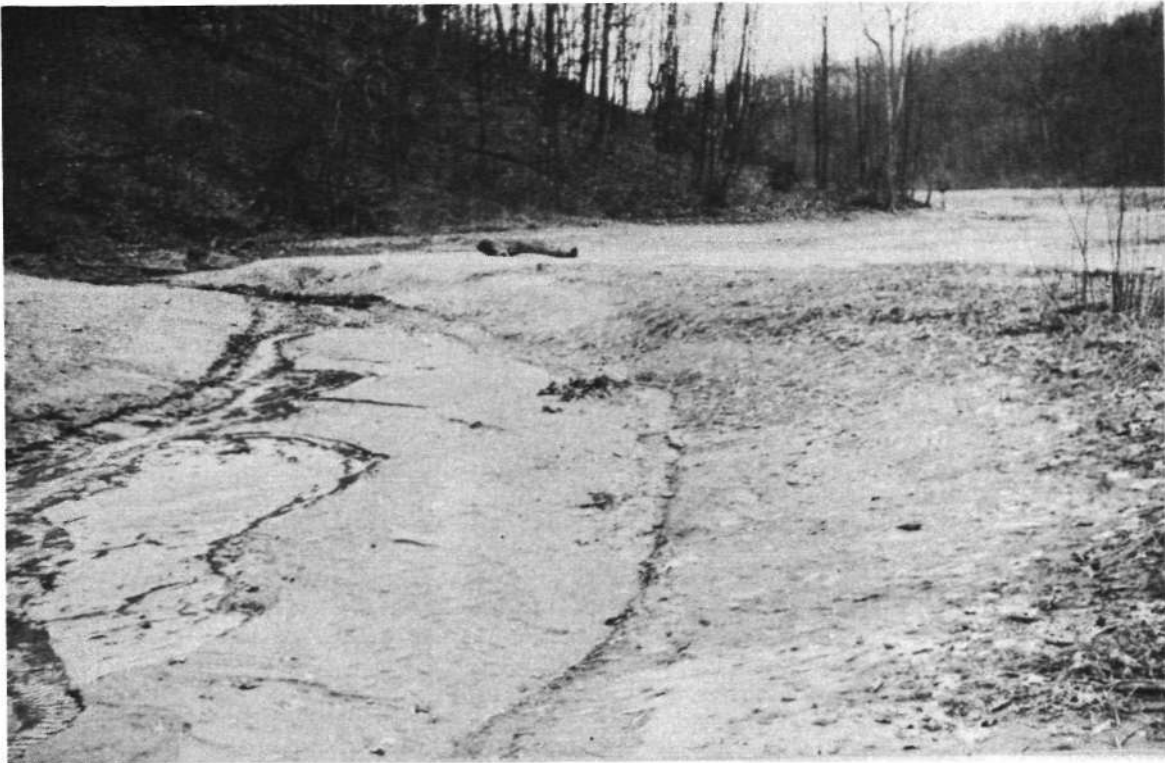
Figure 7. Delta at Inlet of Lake (looking downstream).

At the head of the lake, near the inlet, the thicker underwater deposits and delta deposits

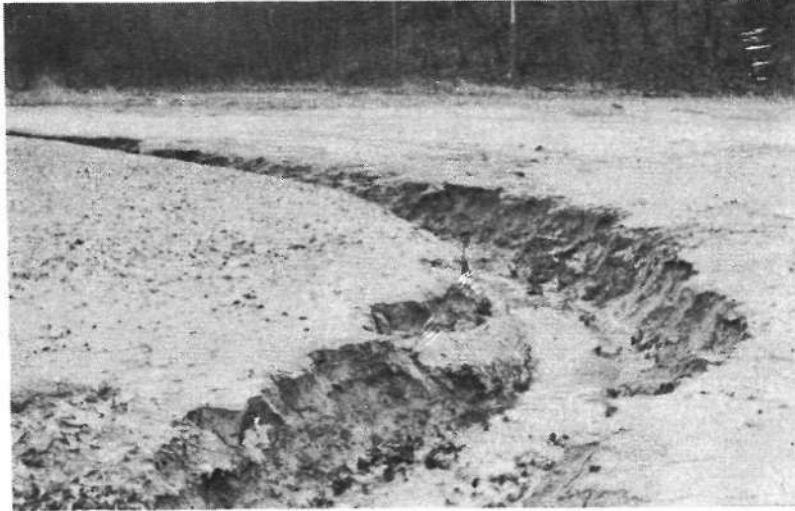
Figure 8. Reservoir Bottom When Lake Was Drained (looking upstream).

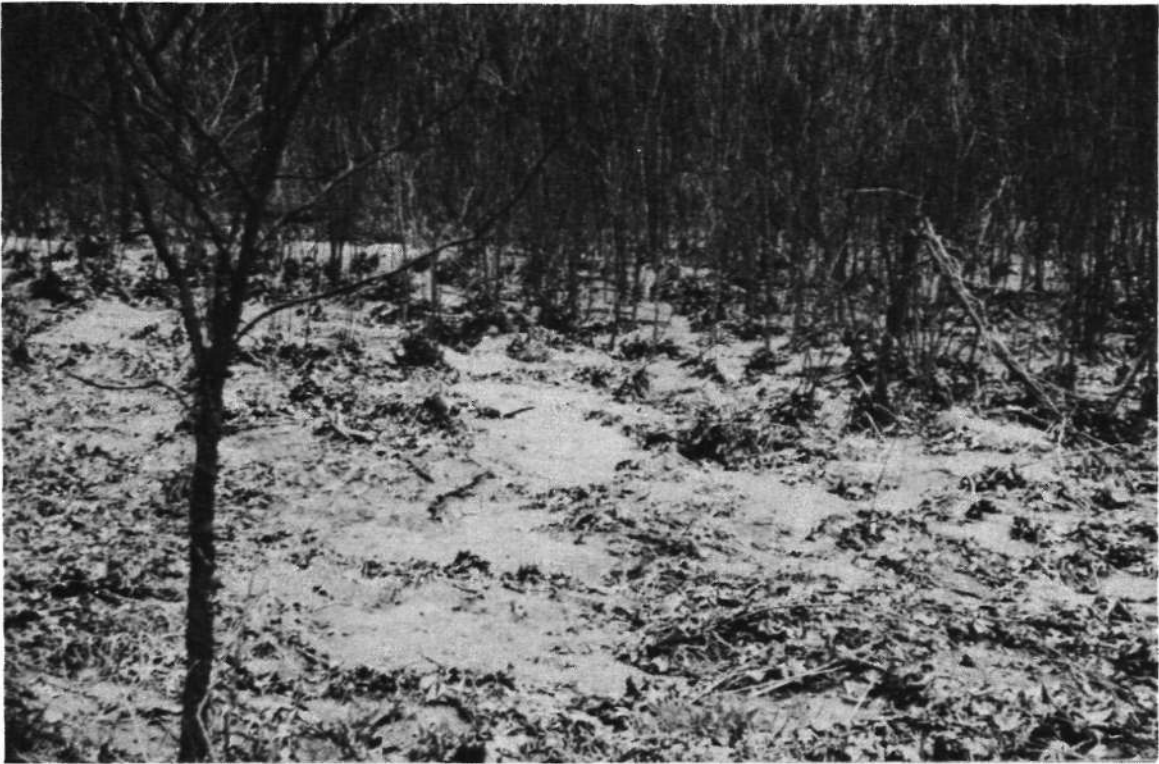
Figure 10. Sediment Deposits in Thick Vegetation on Flood Plainf Creek above Ridge Lake.

ance of the main channel about 2,000 feet above the headwaters of the lake. Although this channel is not believed to be degrading seriously, the steep stream banks may be eroding due to the lateral meanderings of the stream. In period of flood this stream leaves its banks completely and inundates much of the flood plain of the lower stream. At such times the thick vegetation of the flood plain greatly reduces the velocity of runoff and considerable deposition of silt takes place as stated earlier (see Figure 10).

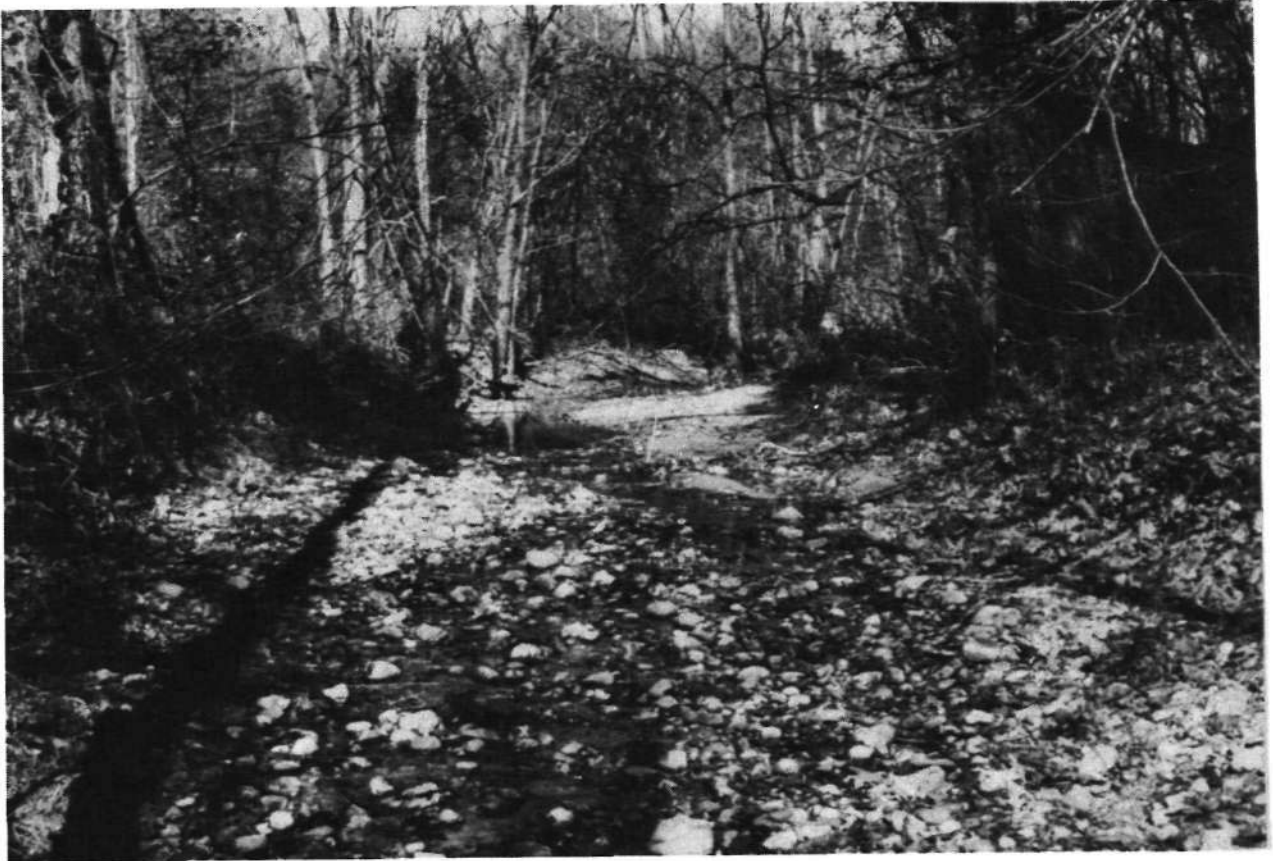
Figure 14. View of Stream Channel above Lake.

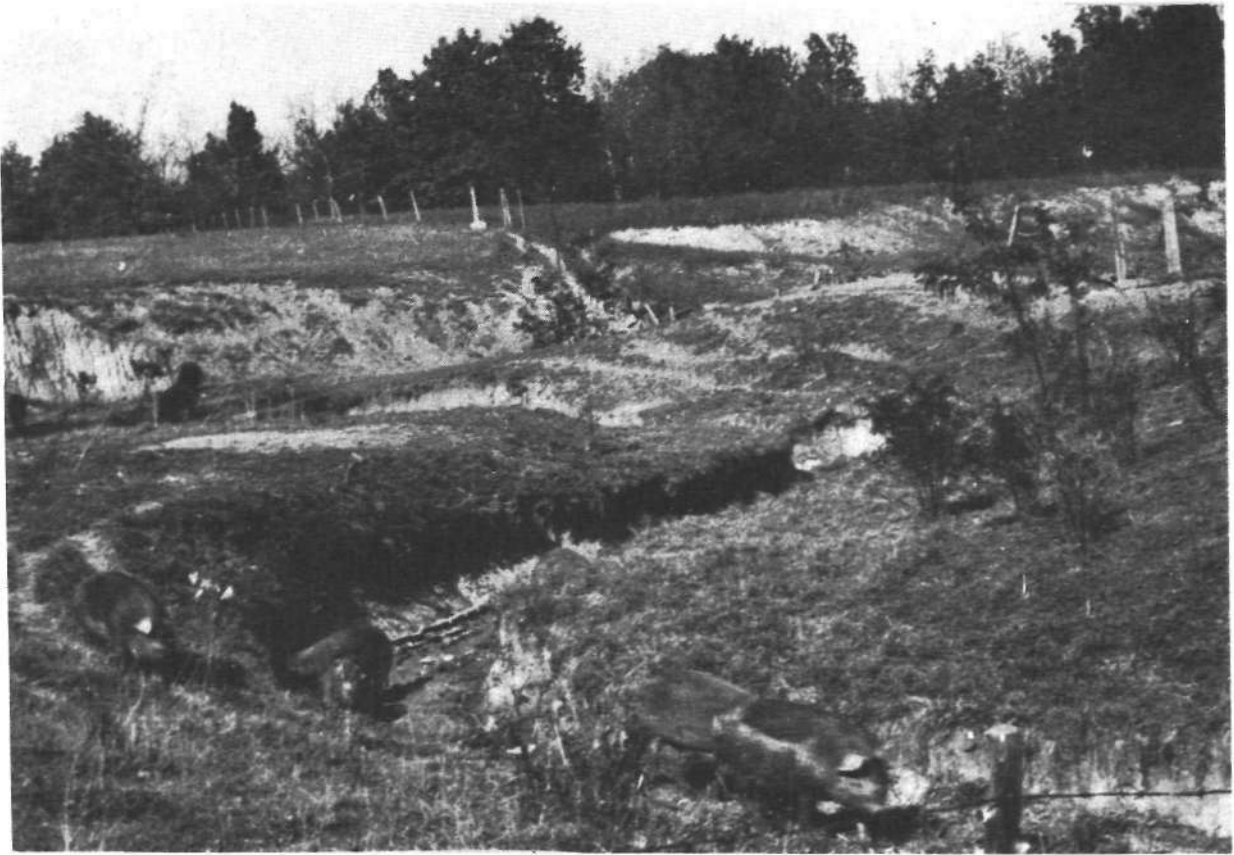
Figure 15. Gully Erosion on One of the Main Waterways Leading into the Lake.

In Figure 15 is shown gully erosion at the head of one of the main waterways leading into Ridge Lake. Note the hogs in the gully. The hogs root loose sod helping to speed up erosion. Areas such as this contribute heavily to the sediment load of the stream which carries it into the lake. The need for control measures is evident in the photograph.
